MEMORANDUM

SUBJECT: Boulder Creek Post-WERT Study
2020 CZU Lightning Complex Burn Area, Santa Cruz County

Cal OES Mission #:
2020-SOC-42611

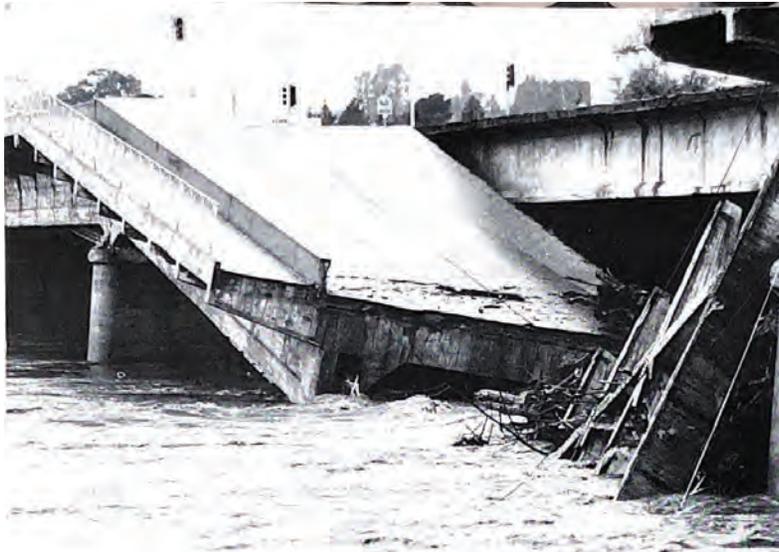
The Soquel Avenue Bridge was the raging San Lorenzo River's major victim in the city of Santa Cruz.

Shortly after 1 a.m., bystanders pointed to a crack on the Soquel Avenue Bridge. Workmen scrambled to their crane and got off the bridge a split-second before one lane of the span collapsed into the raging torrent.

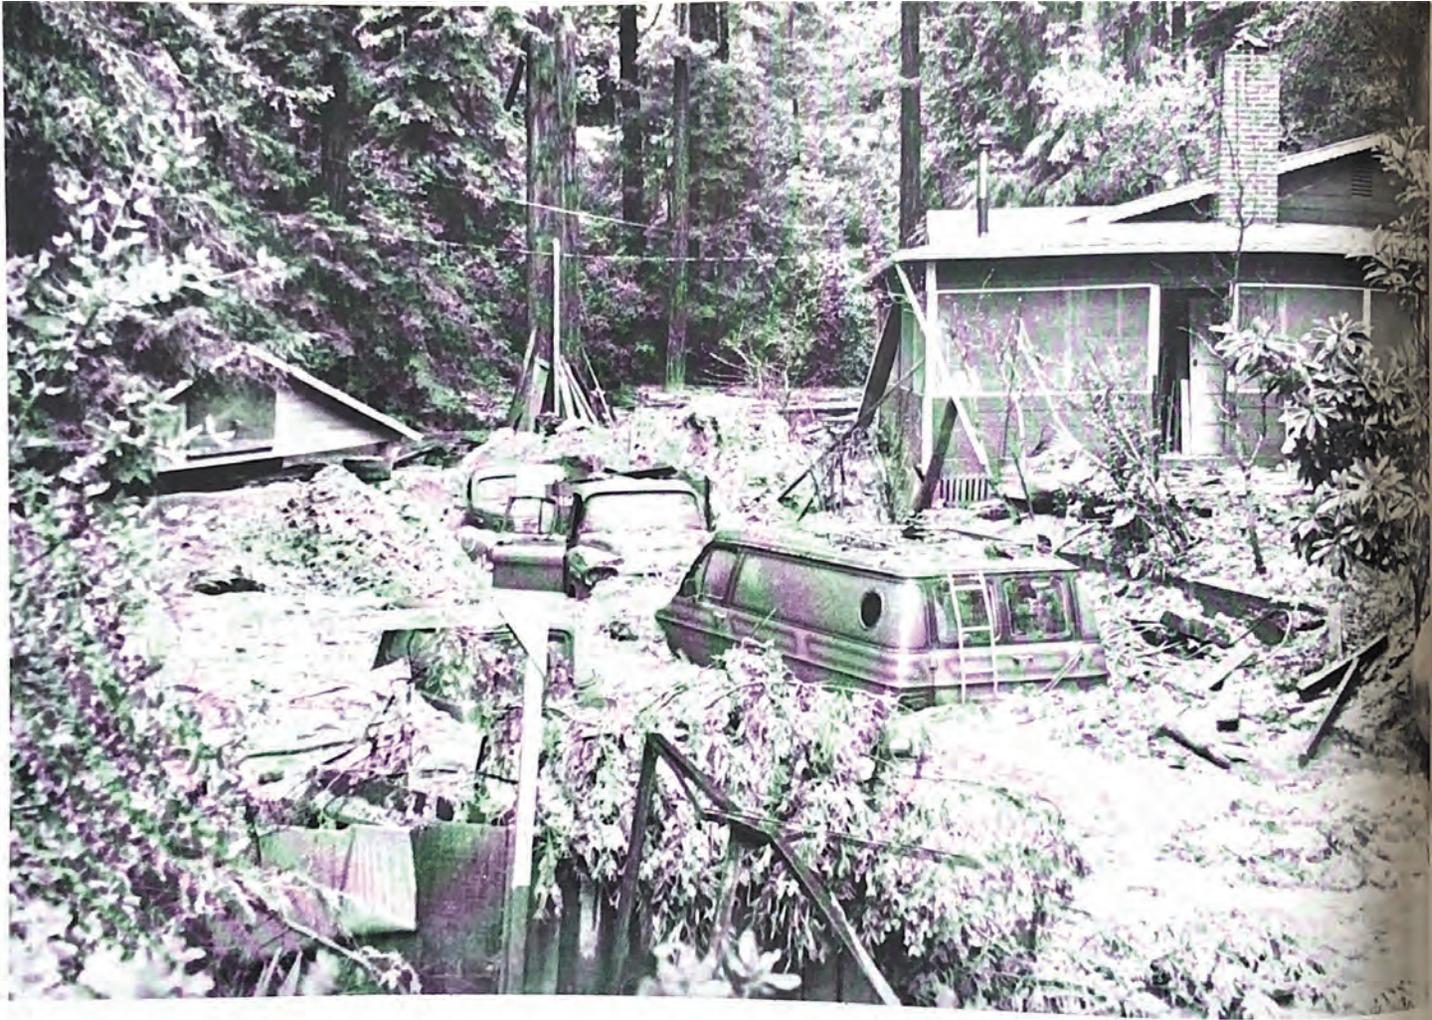
At least four vehicles were buried in mud
at this Highway 9 residence just north of
Boulder Creek.
